Advanced Data Analysis (ADA) Solves the Mystery Why Two Challenging Sites have not Met Remedial Goals

Former Bob's Gulf Cleveland, TN (ID# 3-060017)

Old Hickory Citgo: Facility ID #8-570405 Jackson, TN

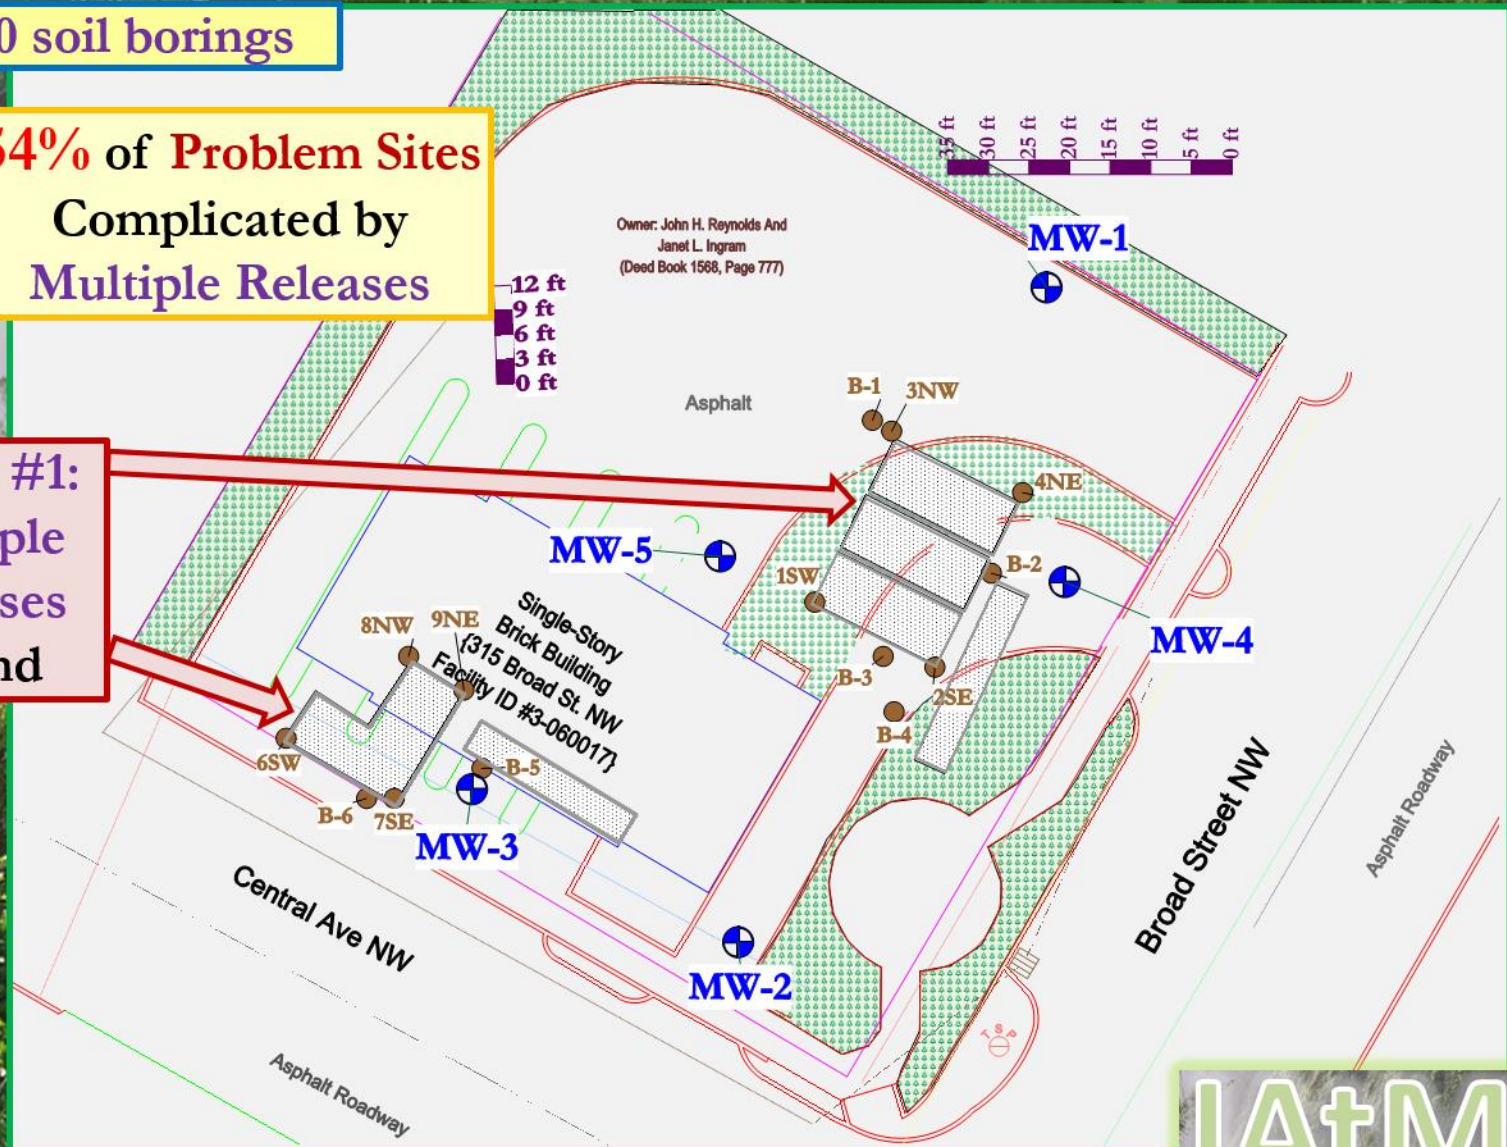
1993 and 2010 soil borings

**54% of Problem Sites
Complicated by
Multiple Releases**

**Cause #1:
Multiple
Releases
Found**

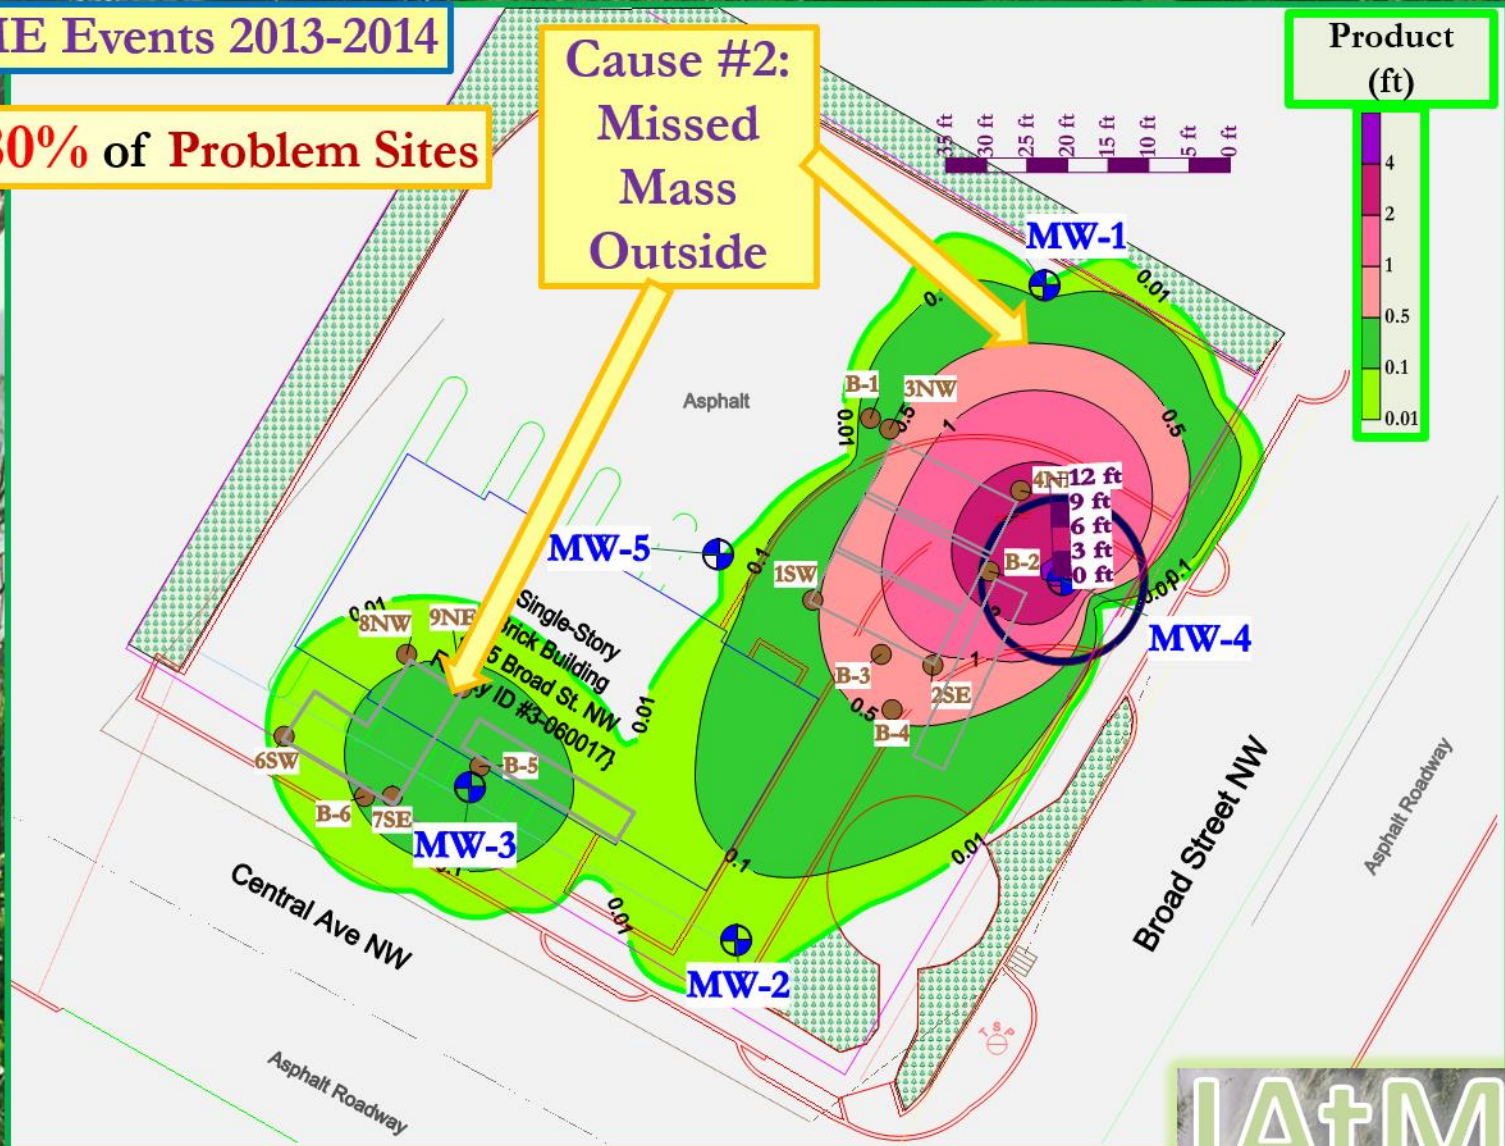
5 Initial MEME Events 2013-2014

80% of Problem Sites

Cause #2:
Missed
Mass
Outside

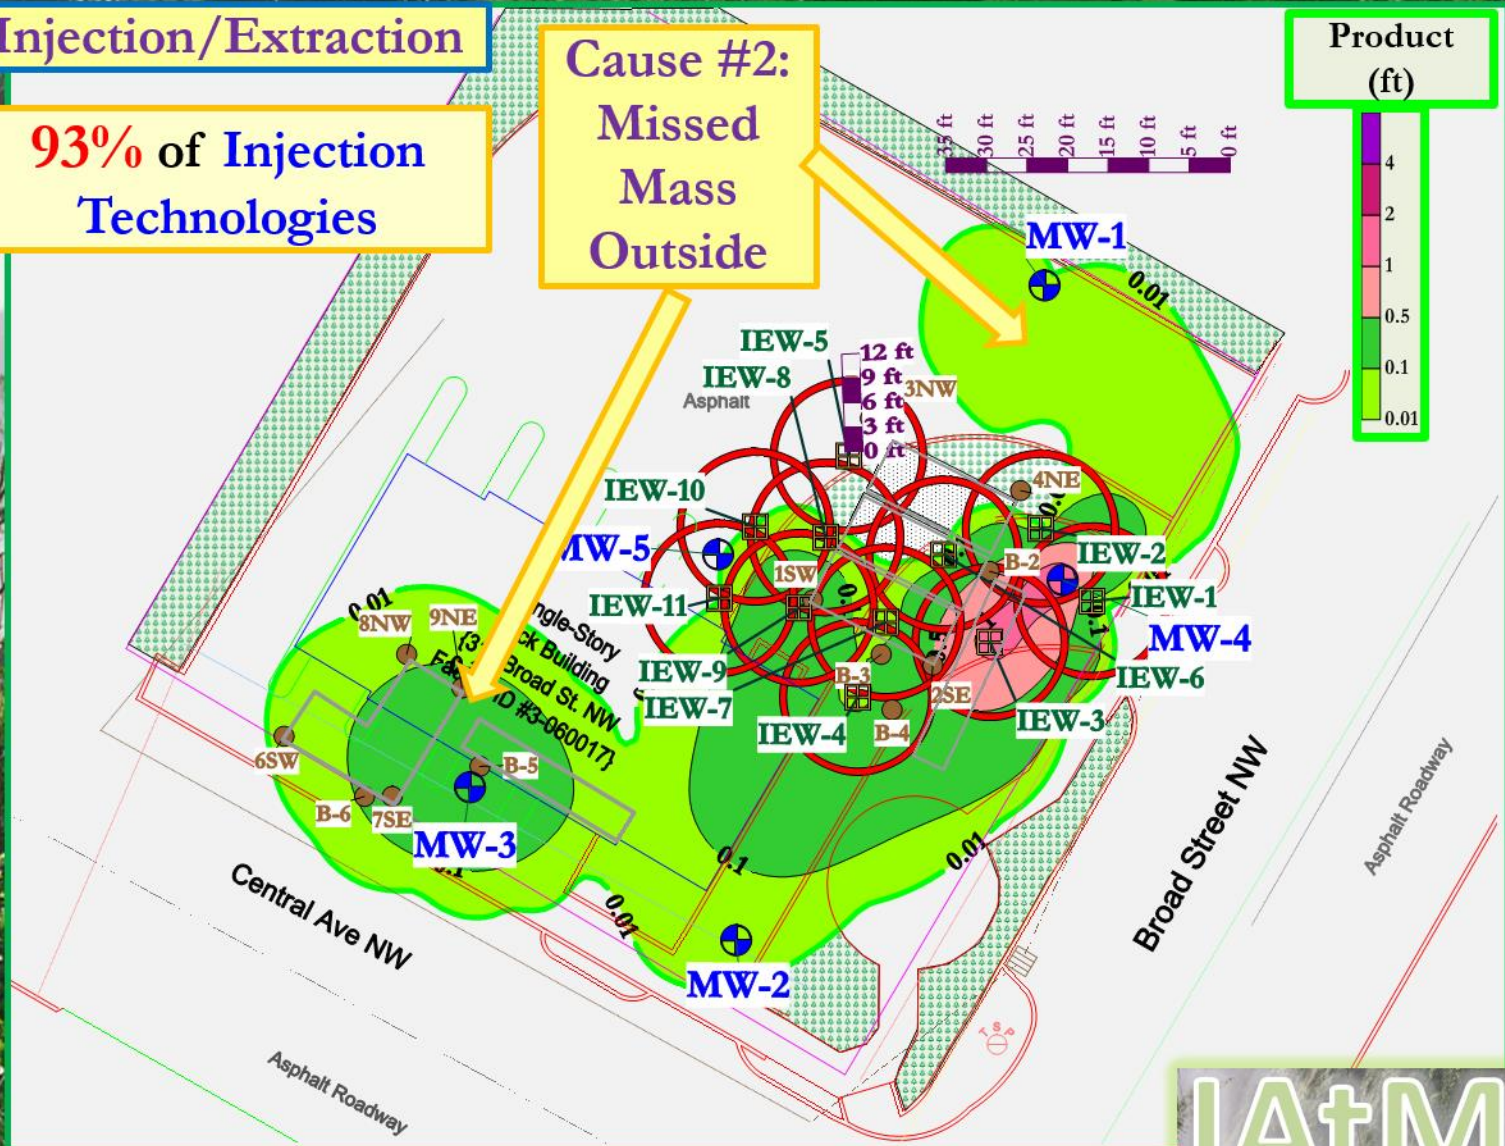
2 Rounds of Injection/Extraction

93% of Injection
Technologies

Cause #2:
Missed
Mass
Outside

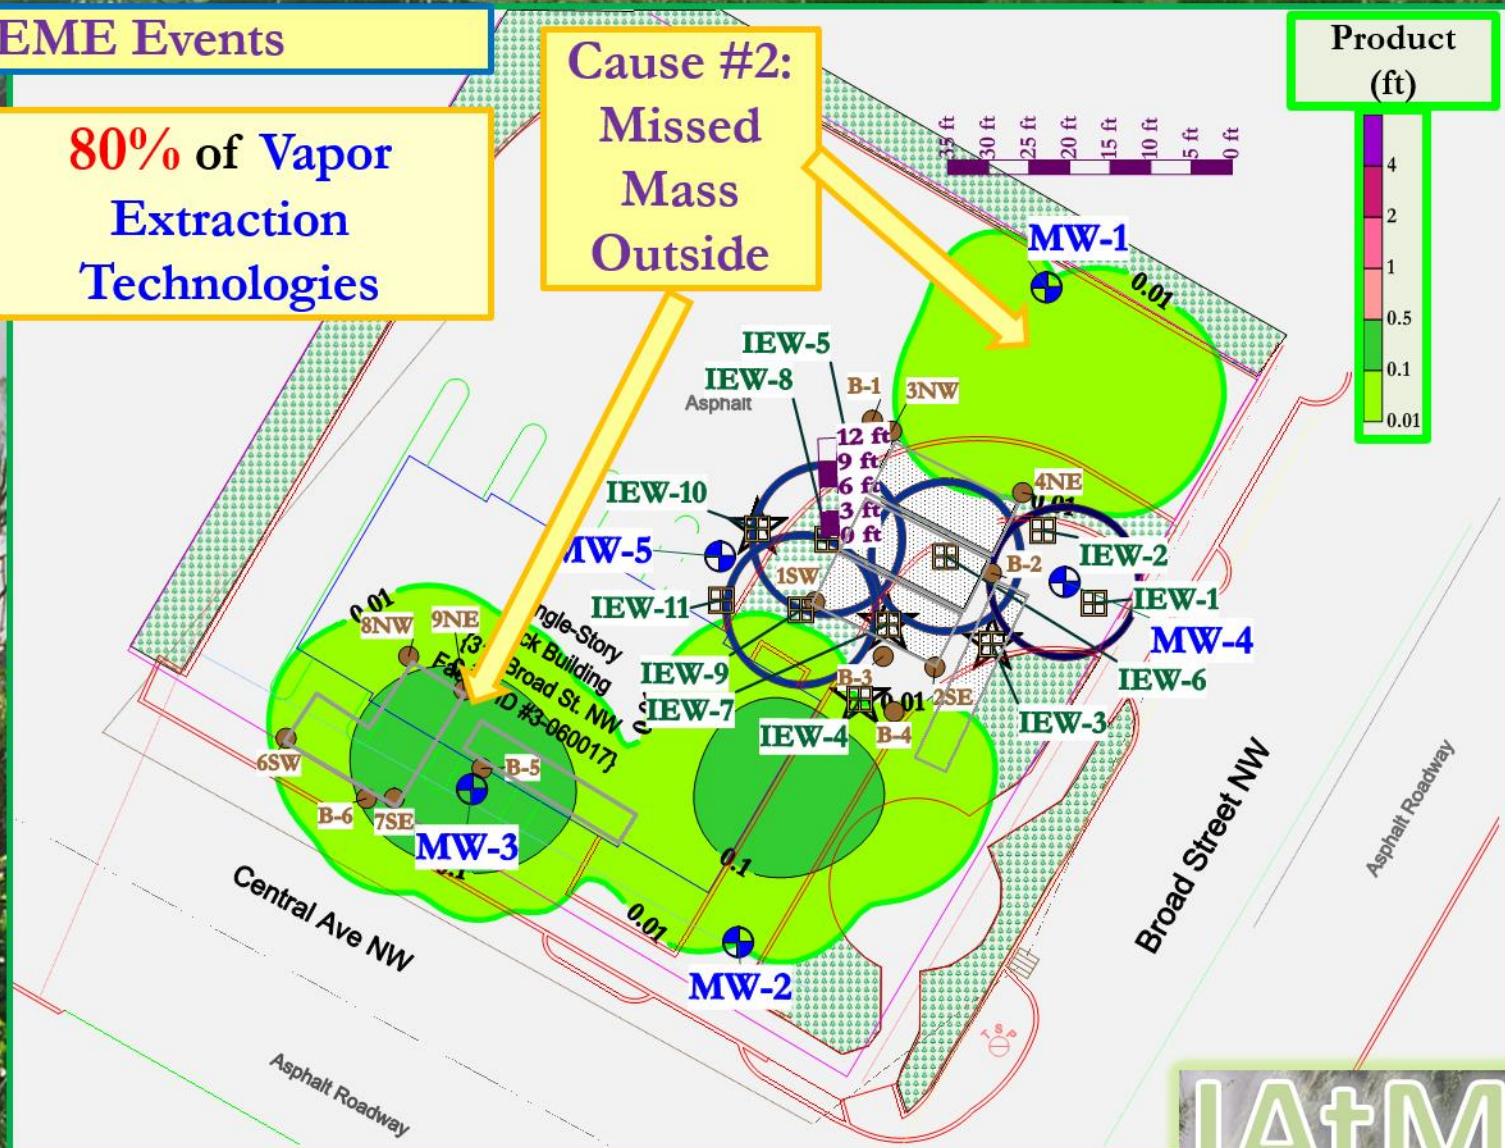
24 MEME Events

80% of Vapor
Extraction
Technologies

Cause #2:
Missed
Mass
Outside

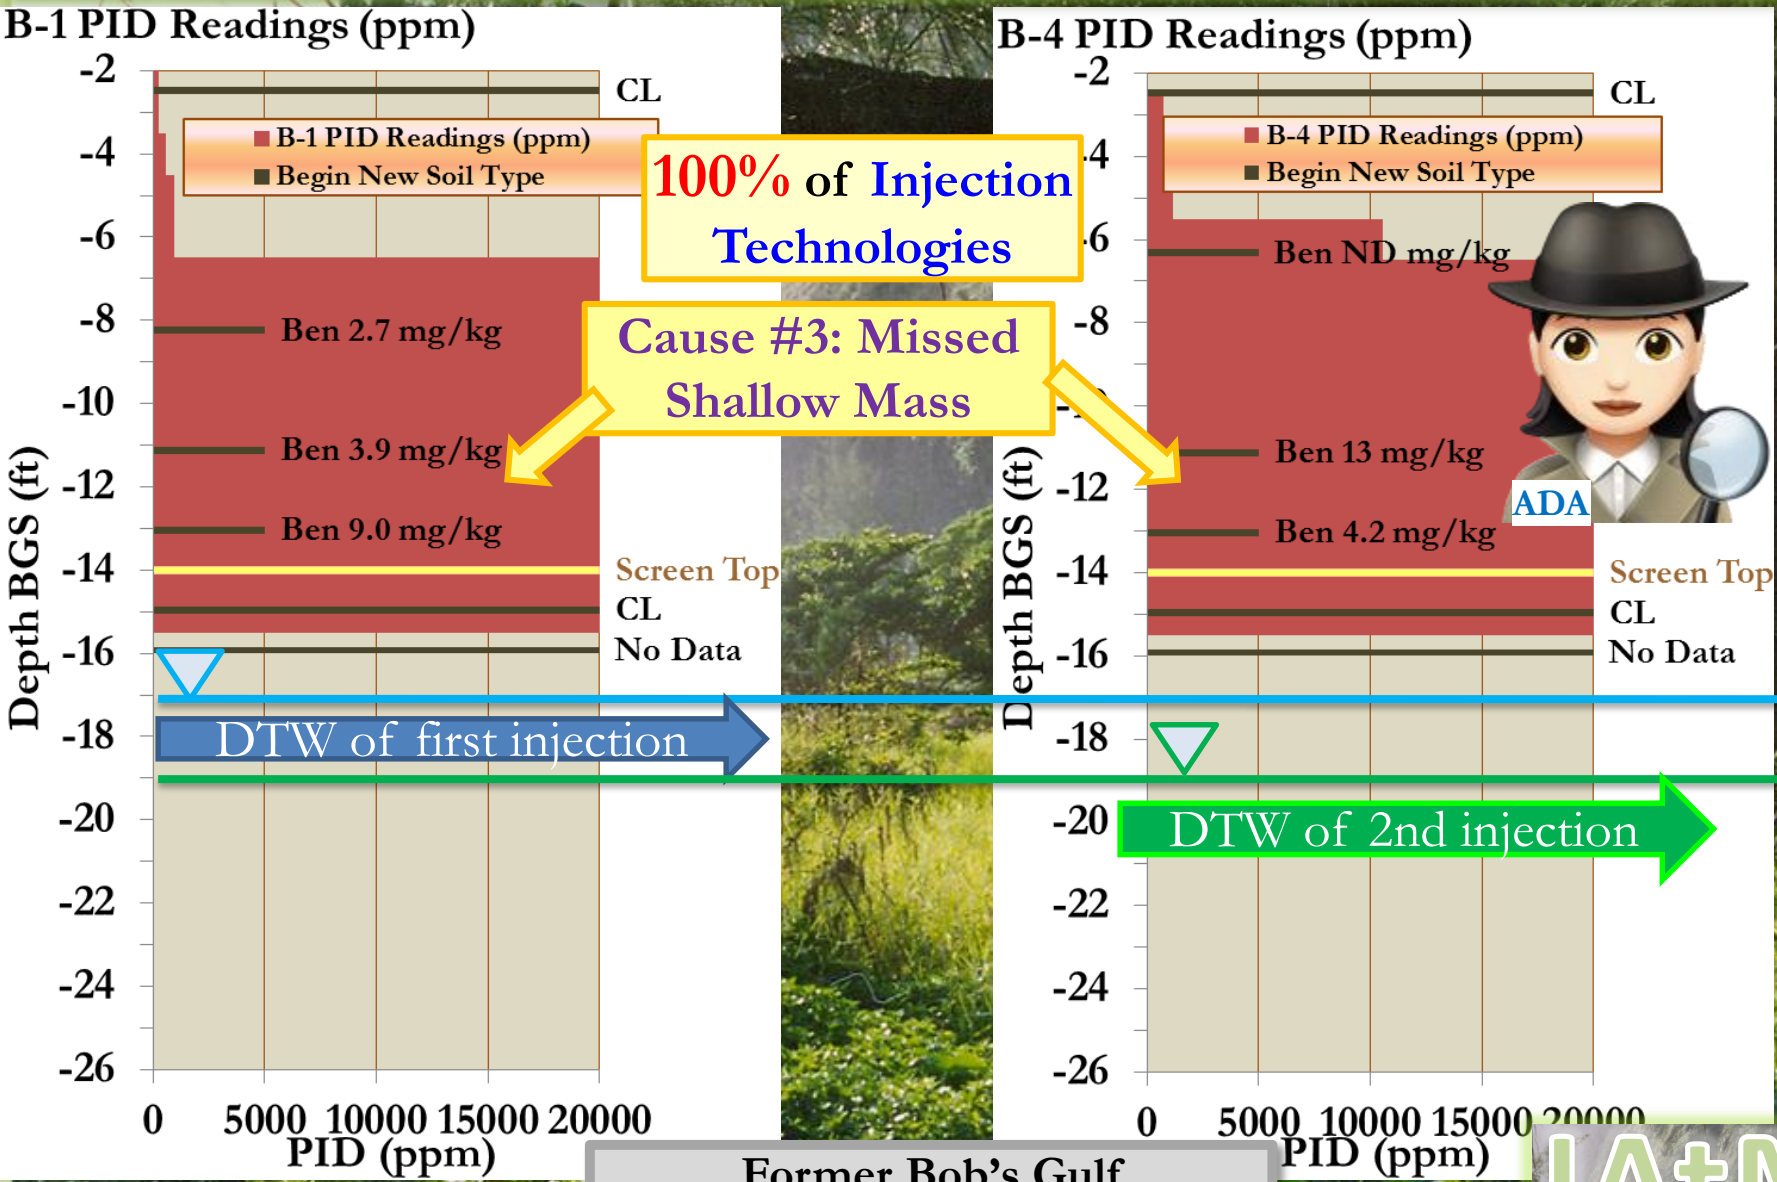
System Efficiency Evaluation (SEE): High Earlier Shallow PIDs in Vadose Zone above DTWs at time Injections Ensures Missed Shallow Mass

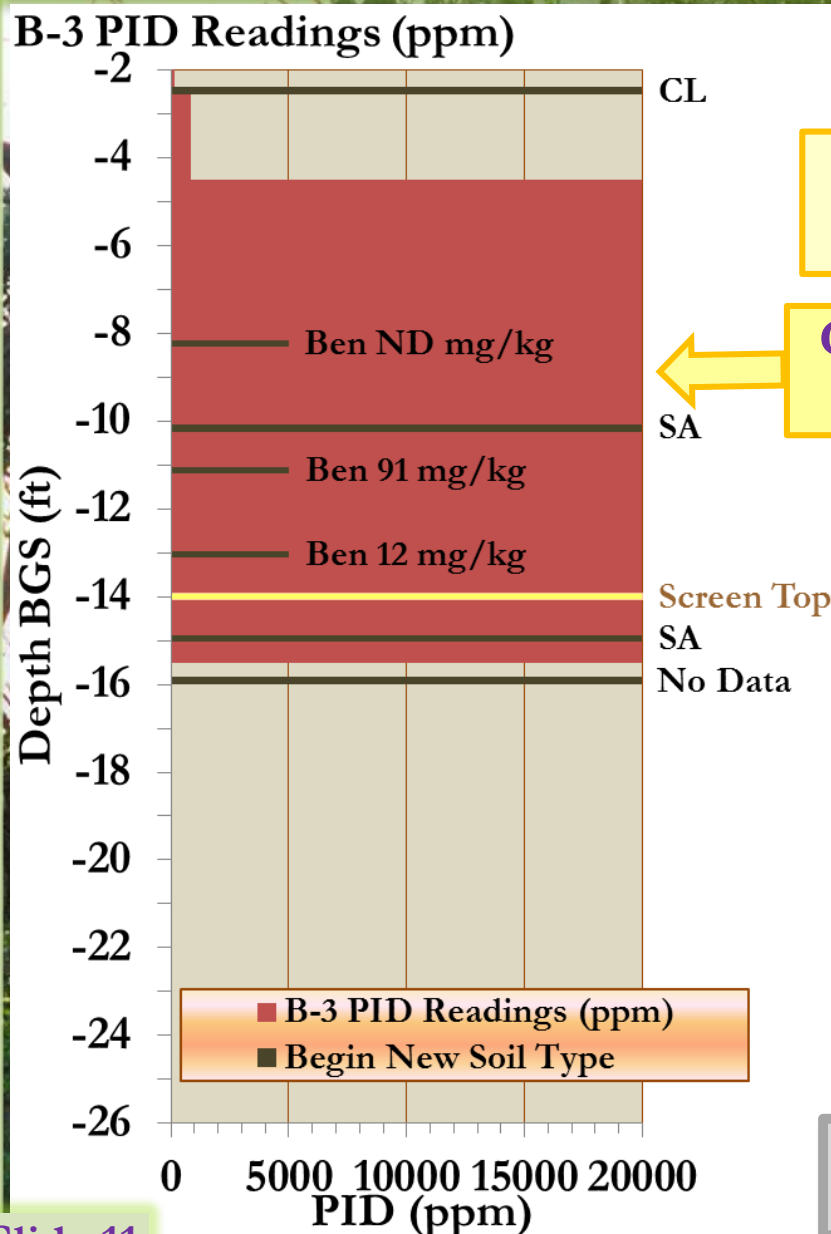
SEE: High Earlier Shallow PIDs in Vadose Zone above Top of Well Screen Still Leaves **Missed Shallow Mass** after **24 MEME Events**

18% of Vapor Technologies

Cause #3: Missed Shallow Mass

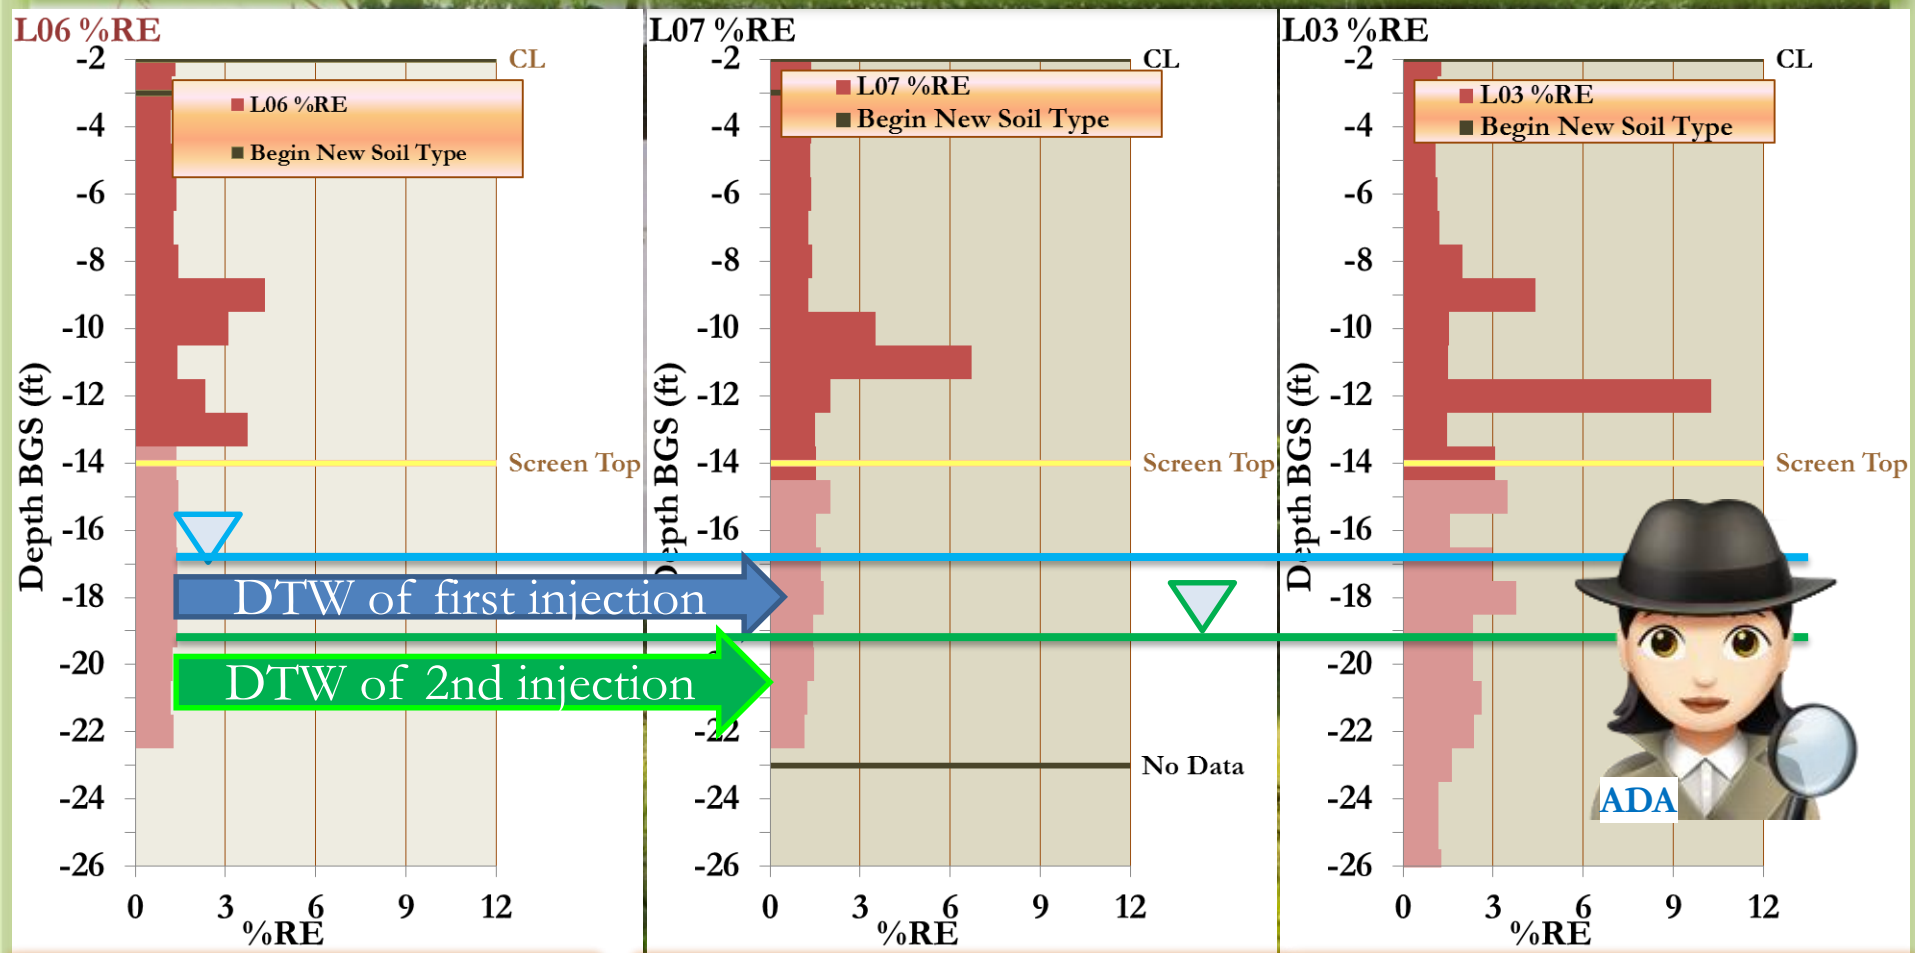
SEE: High LIF Responses above IEW Screen Tops after Injection and MEME Events Confirmed Ineffectiveness of Both for Reducing Shallow Mass

**Clear Low %RE
Confirm Injection ROI
of Greater than 4 feet**

**Not Fully Reduced %RE
at Distance of 7 feet**

**Variable High %RE
ROI of Less than 12 feet**

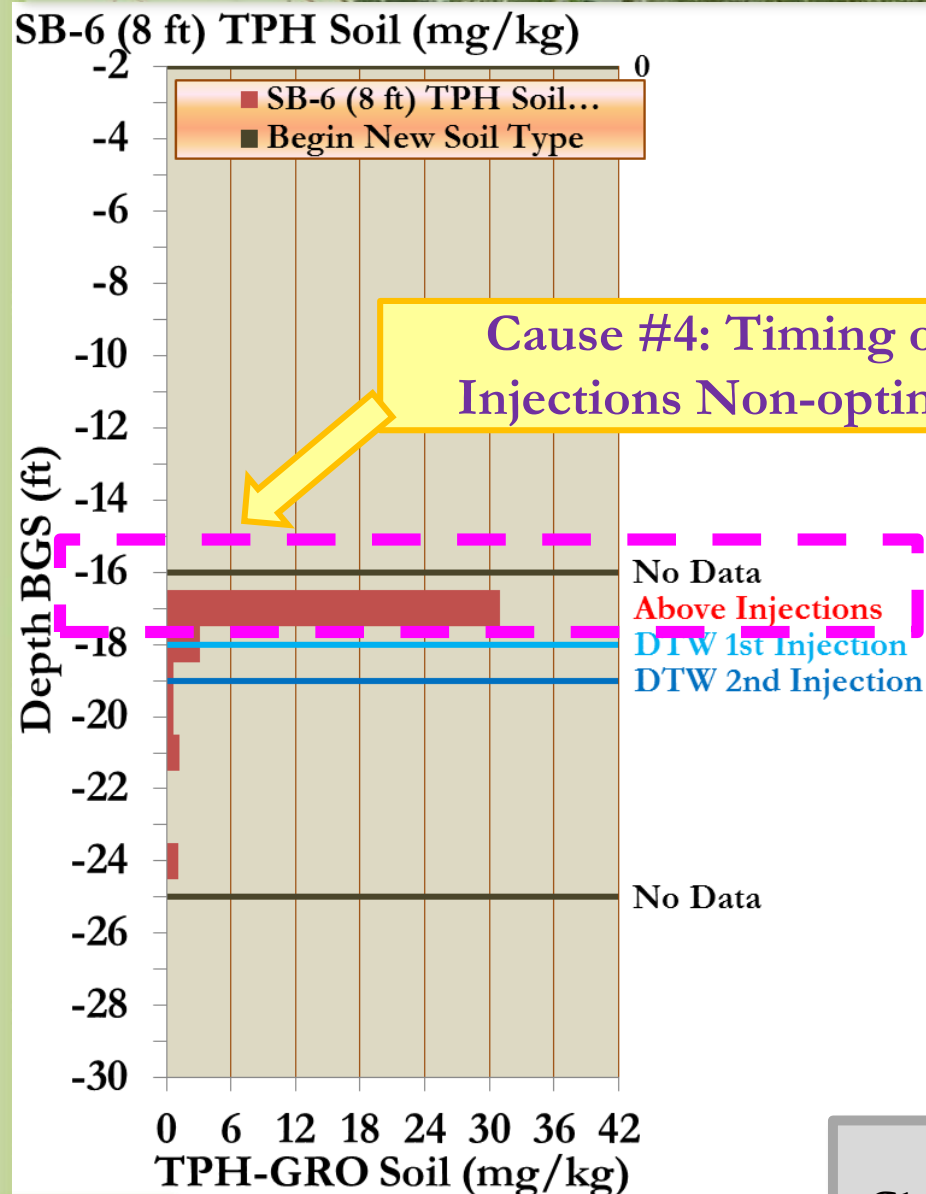
SEE: Timing of Injections Critical: Highest Post-injection Soil Concentrations at or Above DTW of First Injection. Non-optimal Time for Second Injection

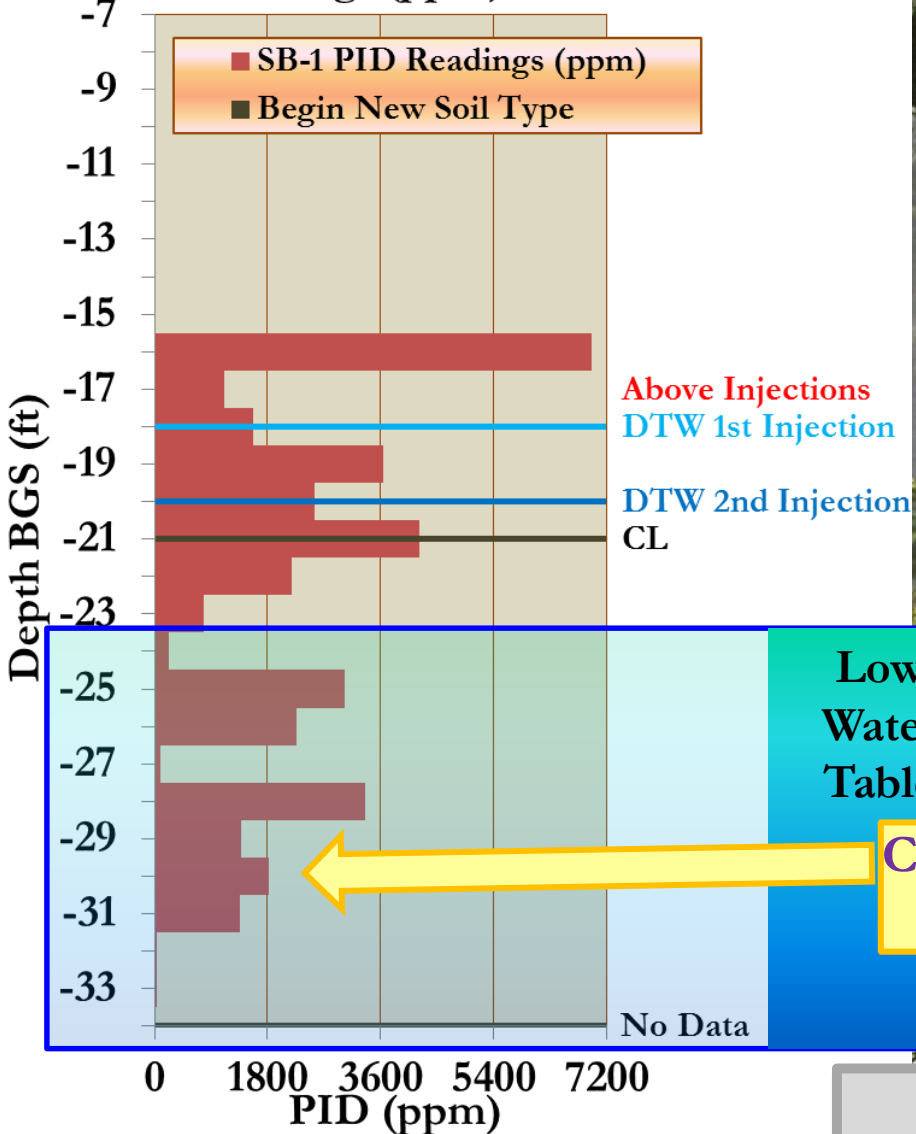
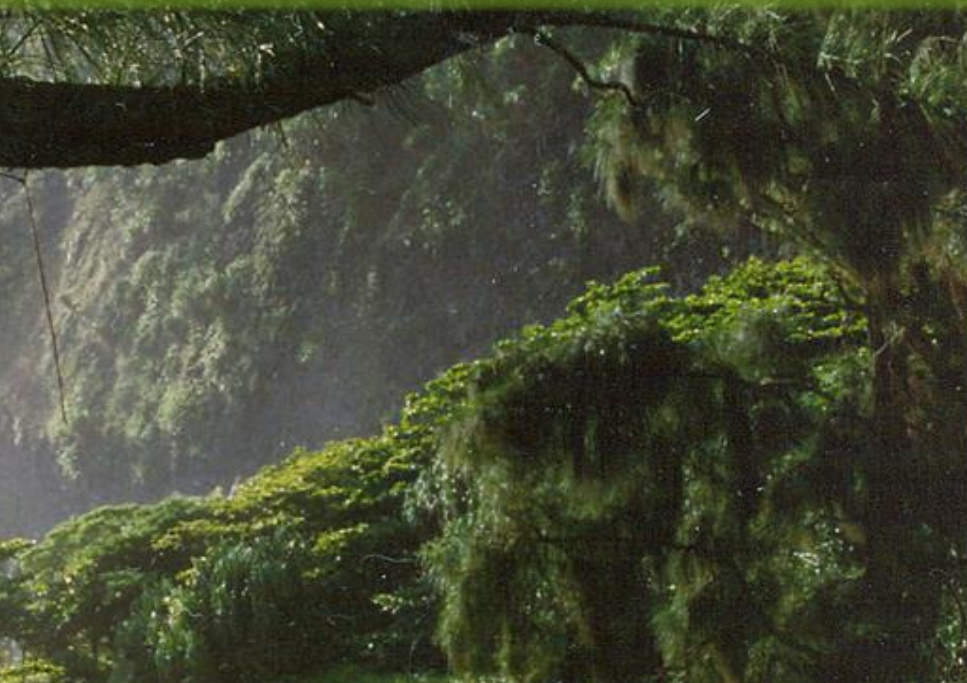
SB-1 PID Readings (ppm)

SEE: Significant Submerged Mass below Low Water Table Could Undermine Future **MEME** Events or Dedicated **DPE:** More **Injections** Could be Needed

76% of Vapor Technologies

Cause #5: Missed Deep Submerged Mass

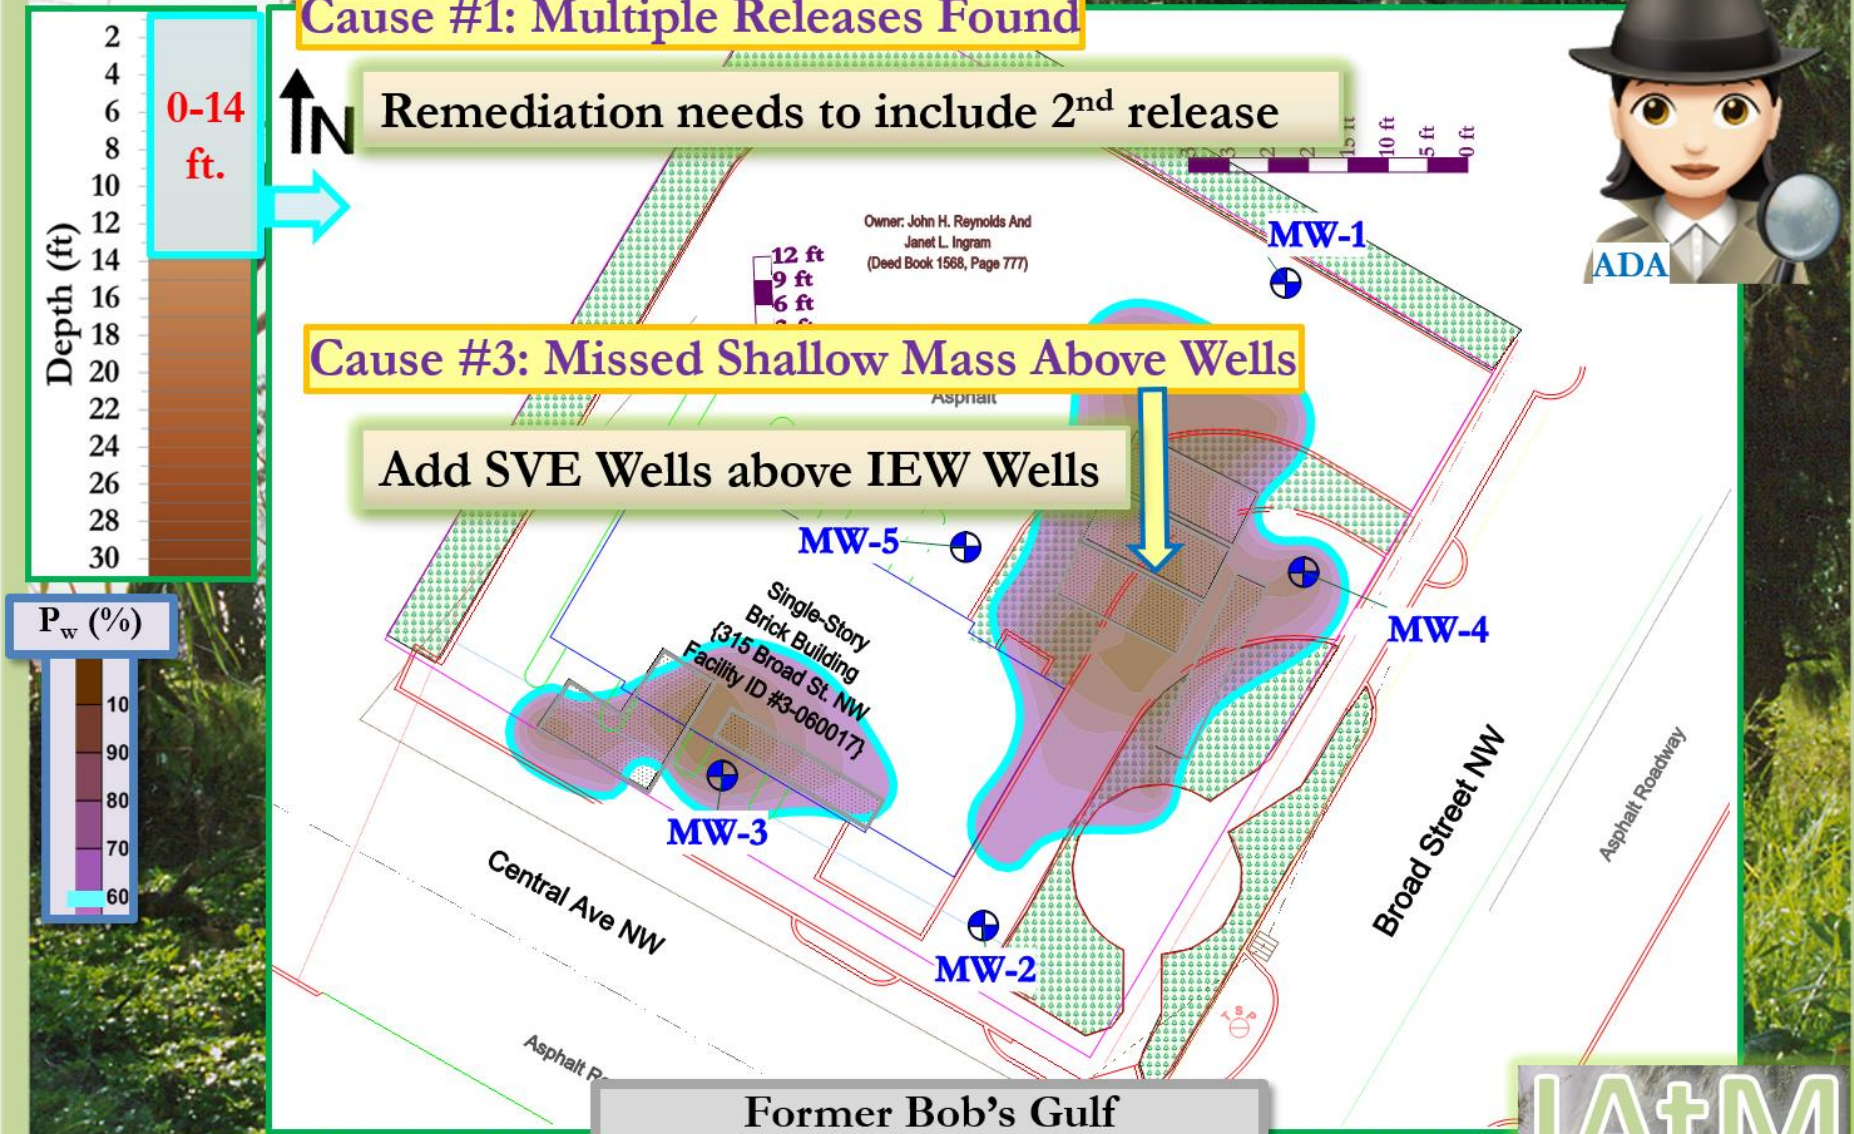
Cause #1: Multiple Releases Found

Cause #3: Missed Shallow Mass Above Wells

Suggestions: Install SVE 4-inch Recovery Wells Down to Water Table and/or Shallow Injections Wells Near Exceeding IEWs with Missed Mass Above

Remediation needs to include 2nd release

Add SVE Wells above IEW Wells

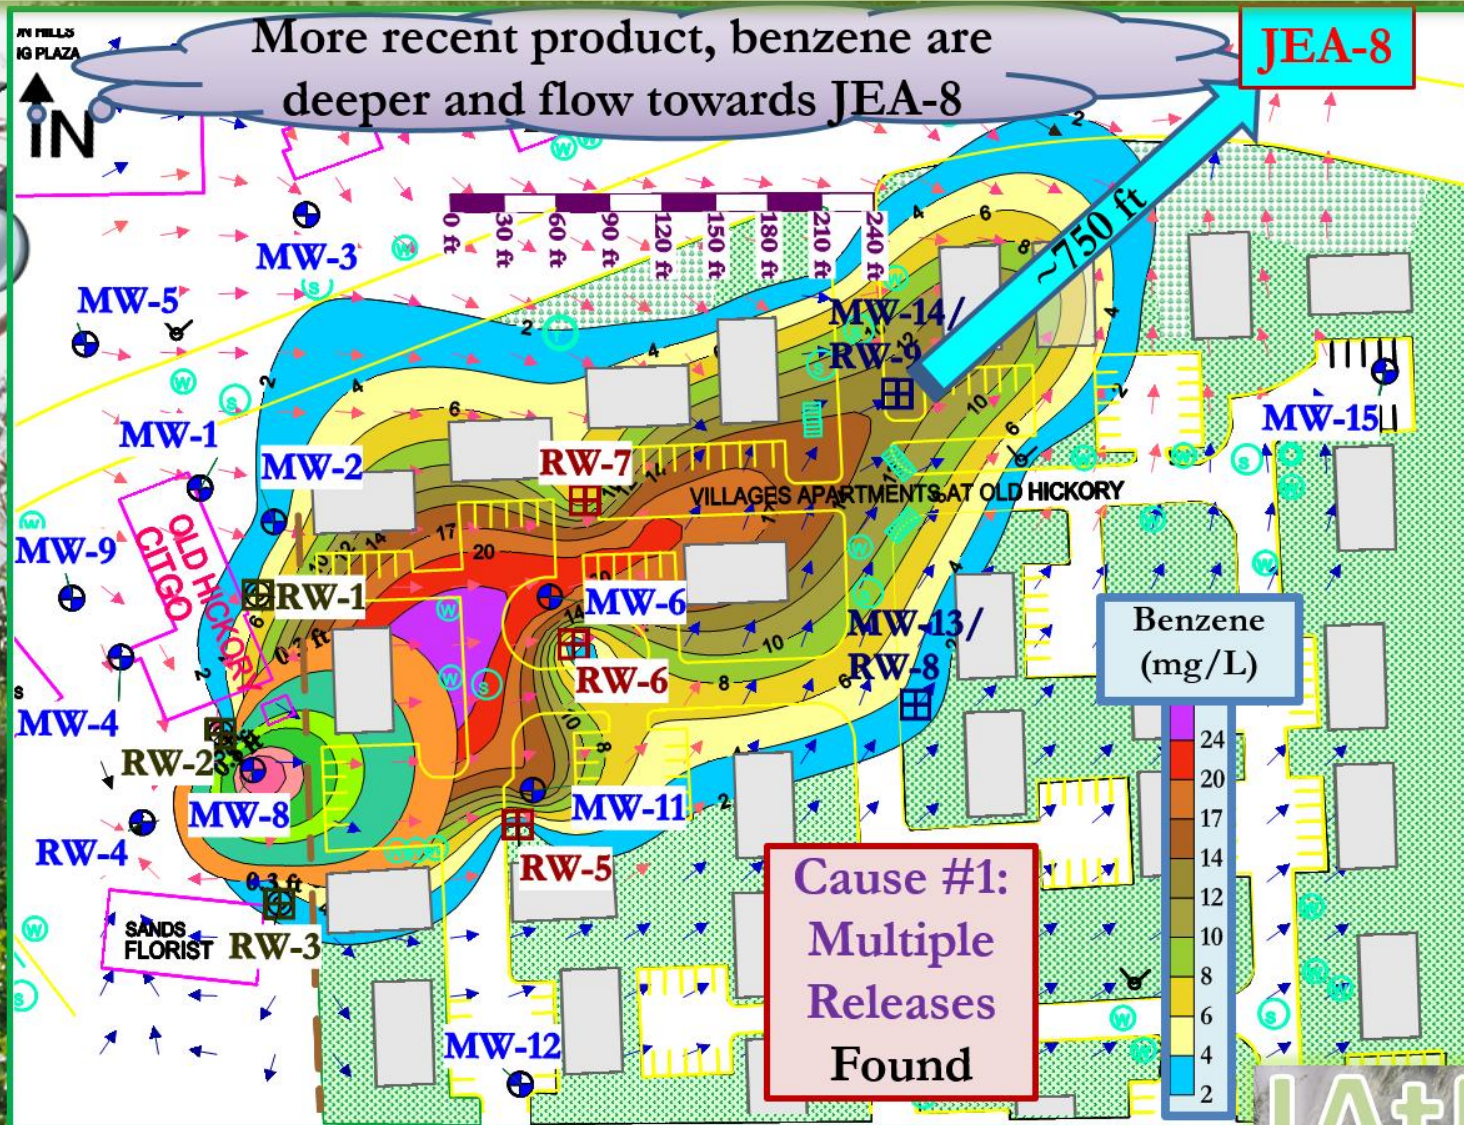
December
2015 flow
gradients

Cause #1:
Multiple
Releases
Found

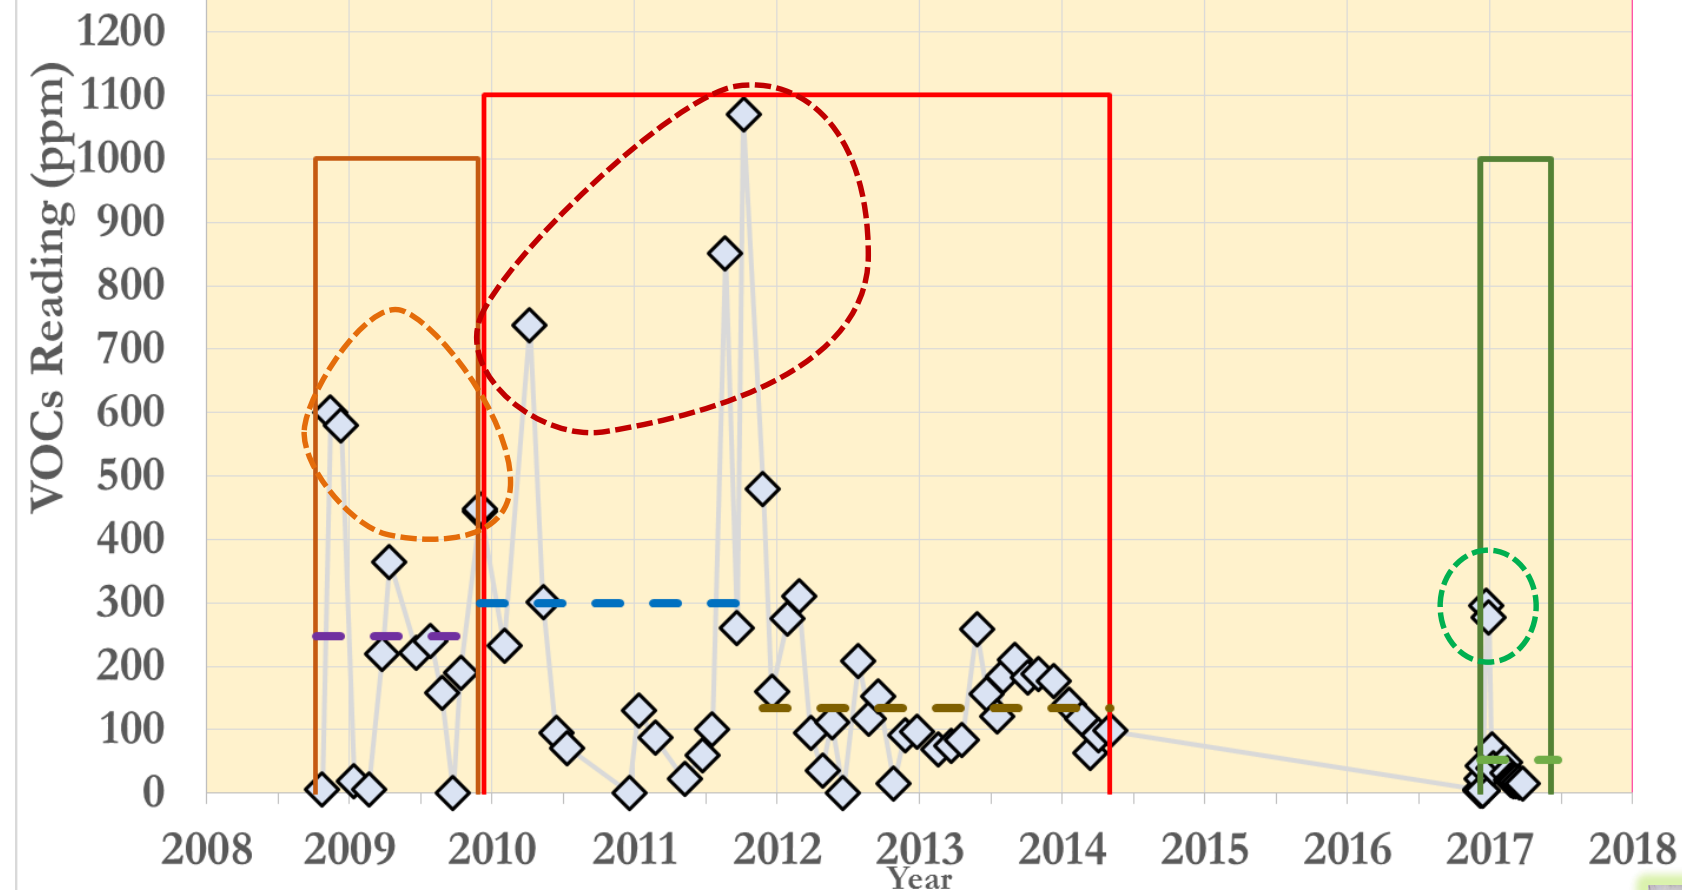
SEE: Observed VOCs during Recovery

- ◇ Emissions OVD reading (ppm)
- CAS 1 On: RW-1,RW-2, RW-3
- CAS 2 On: Adds RW-5,RW-6, RW-7
- CAS 3 On: 5 Off-site wells in grass
- Ave VOC CAS 1: 248 ppm
- Ave VOC CAS 2: 300 ppm
- Ave CAS 2 After Max: 134 ppm
- Ave VOC CAS 3: 52 ppm

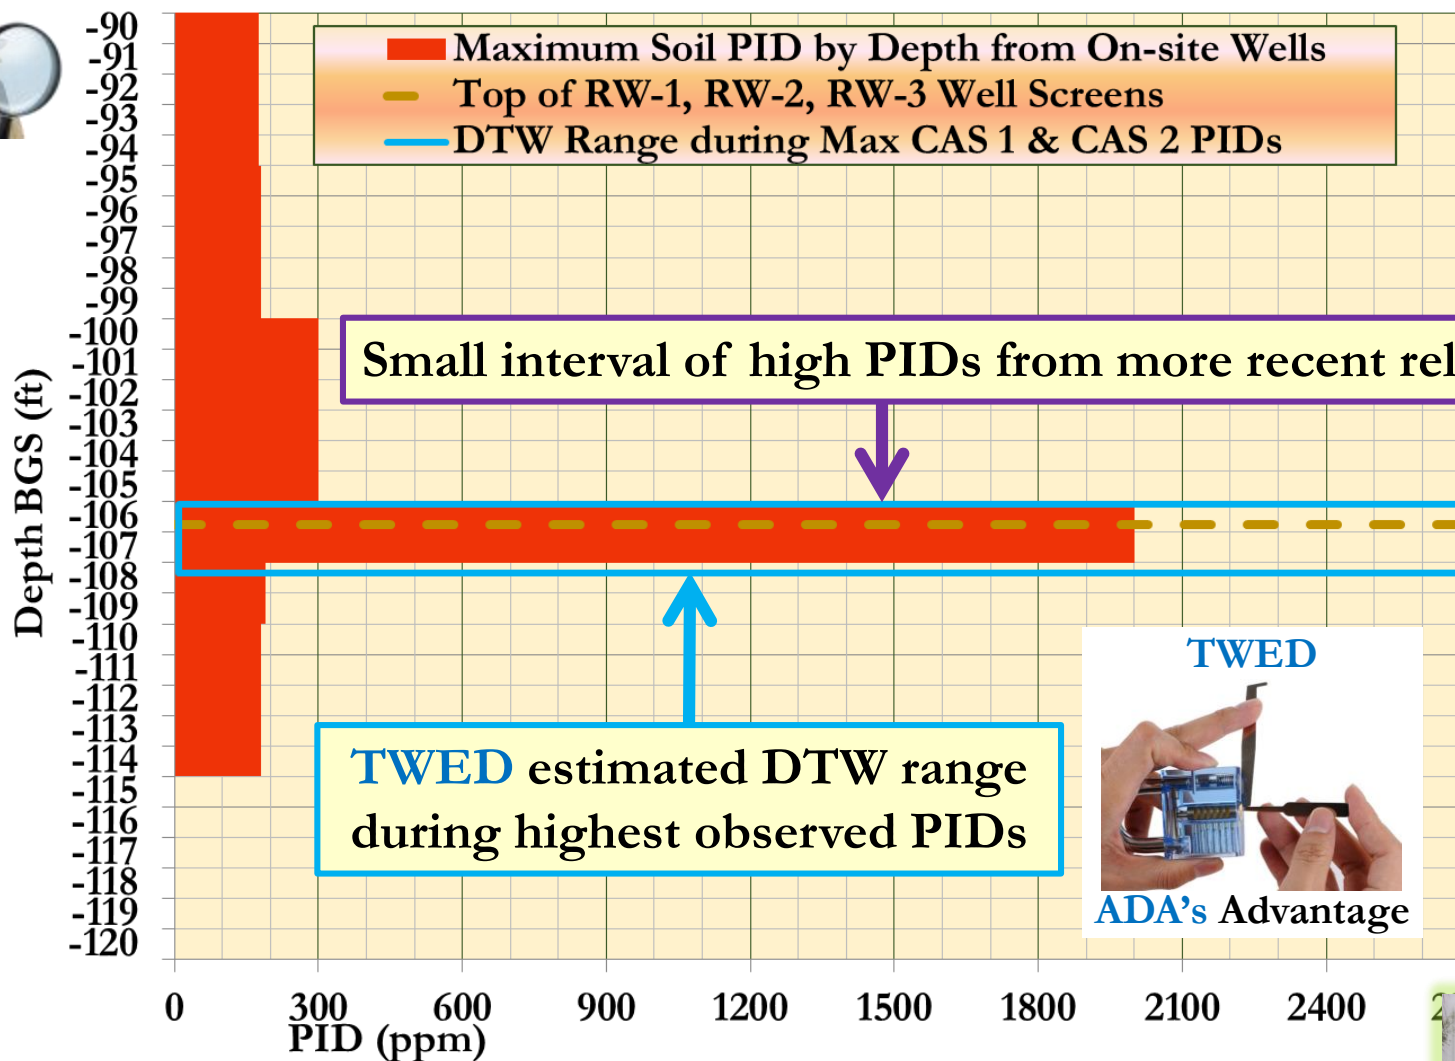
Maximum Soil PID by Depth from On-site Wells

SEE: Small Interval of Significantly Higher Soil PIDs Corresponds to DTW Range when Maximum VOCs Recovery Occurred **On-site (CAS 1 & CAS 2)**
